Title: Bathroom Renovations CCRI Knight Campus

### ADDENDUM #01

### RE: Report – Limited Pre-Renovation Inspection for Materials Suspected of Containing Asbestos Restrooms Upgrade Project - Site: Main Building, CCRI Knight Campus, Warwick, RI 02886 RI Analytical Laboratories, Inc. Project #2020107

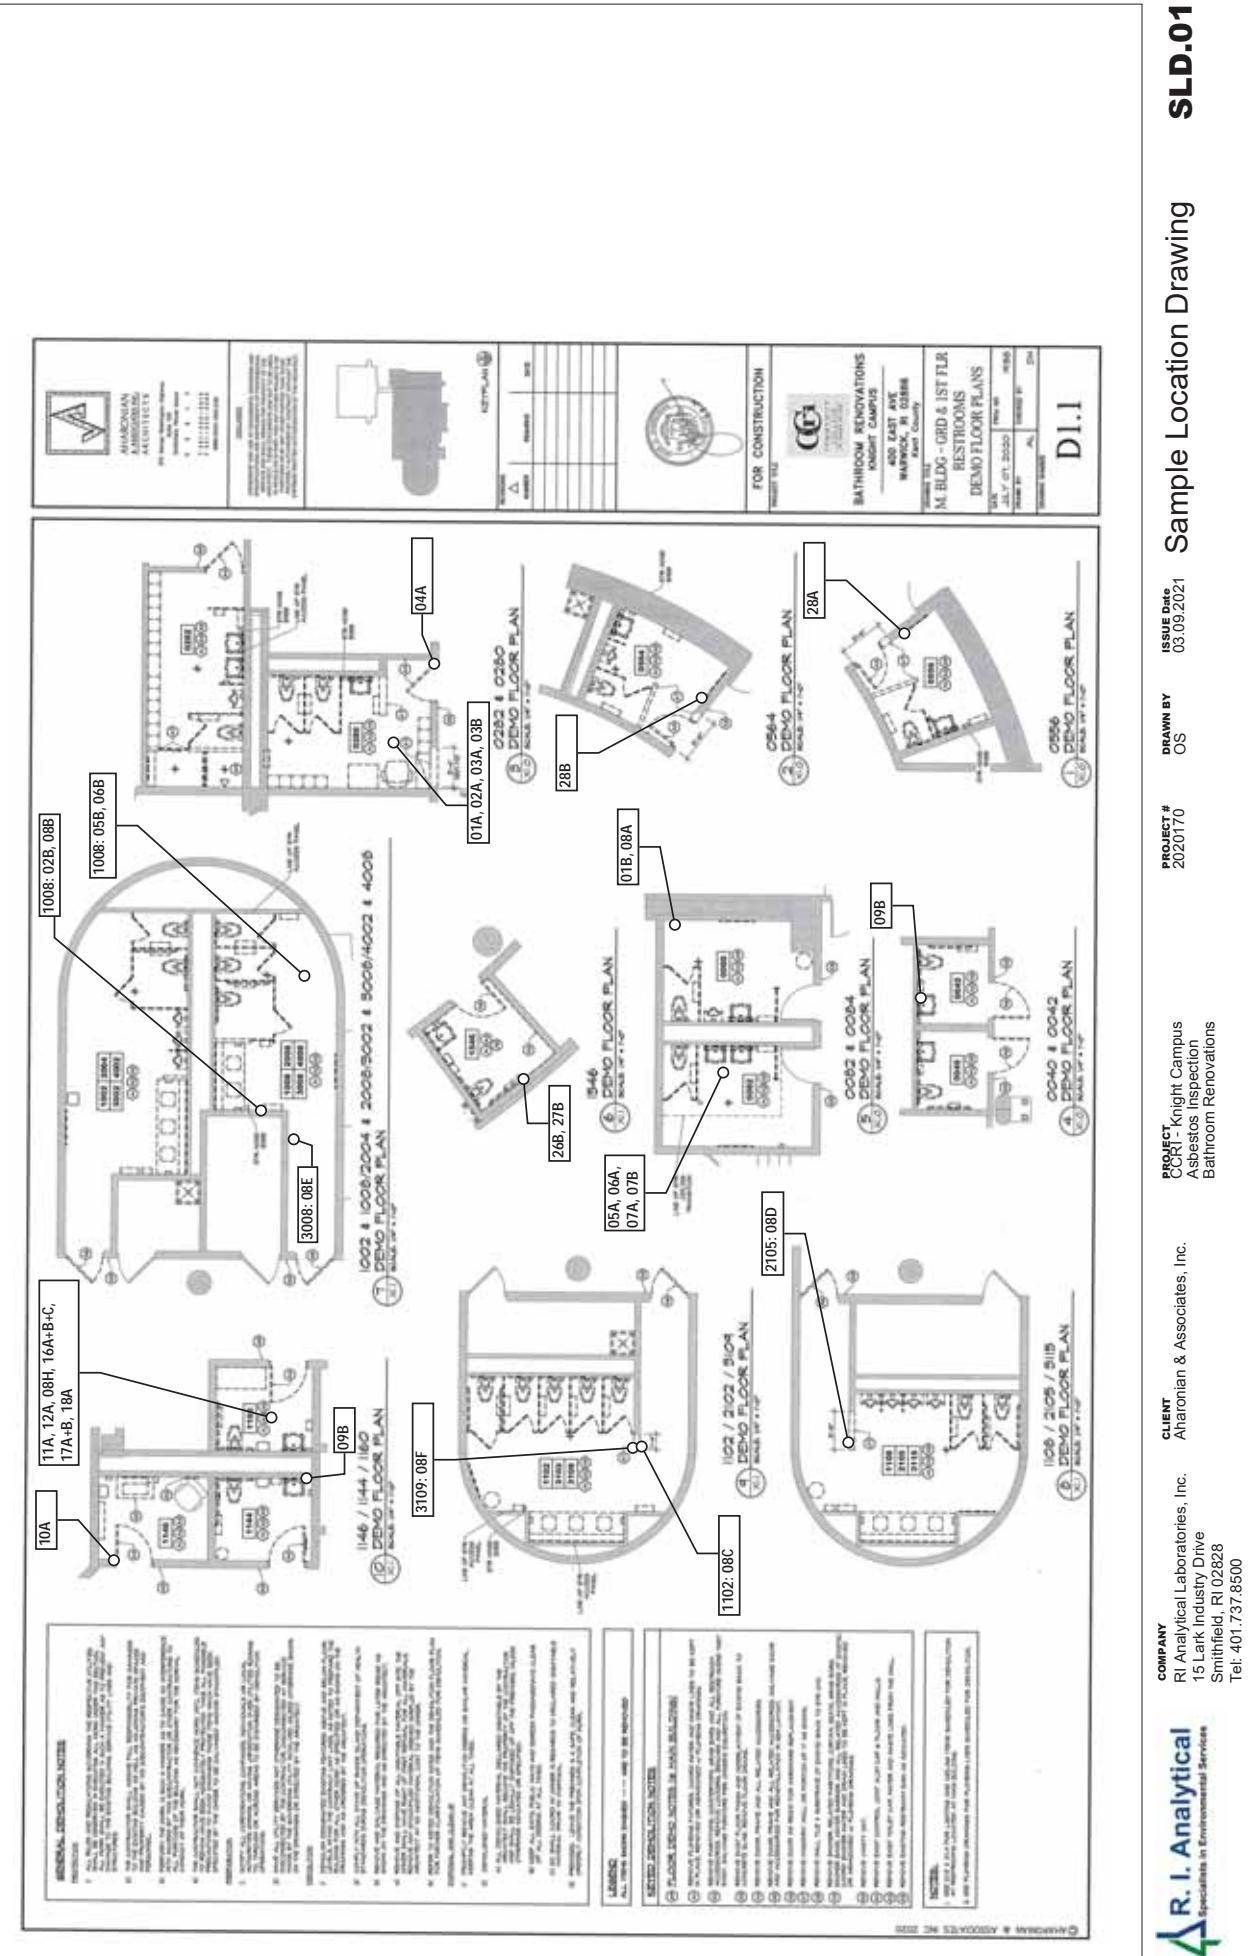
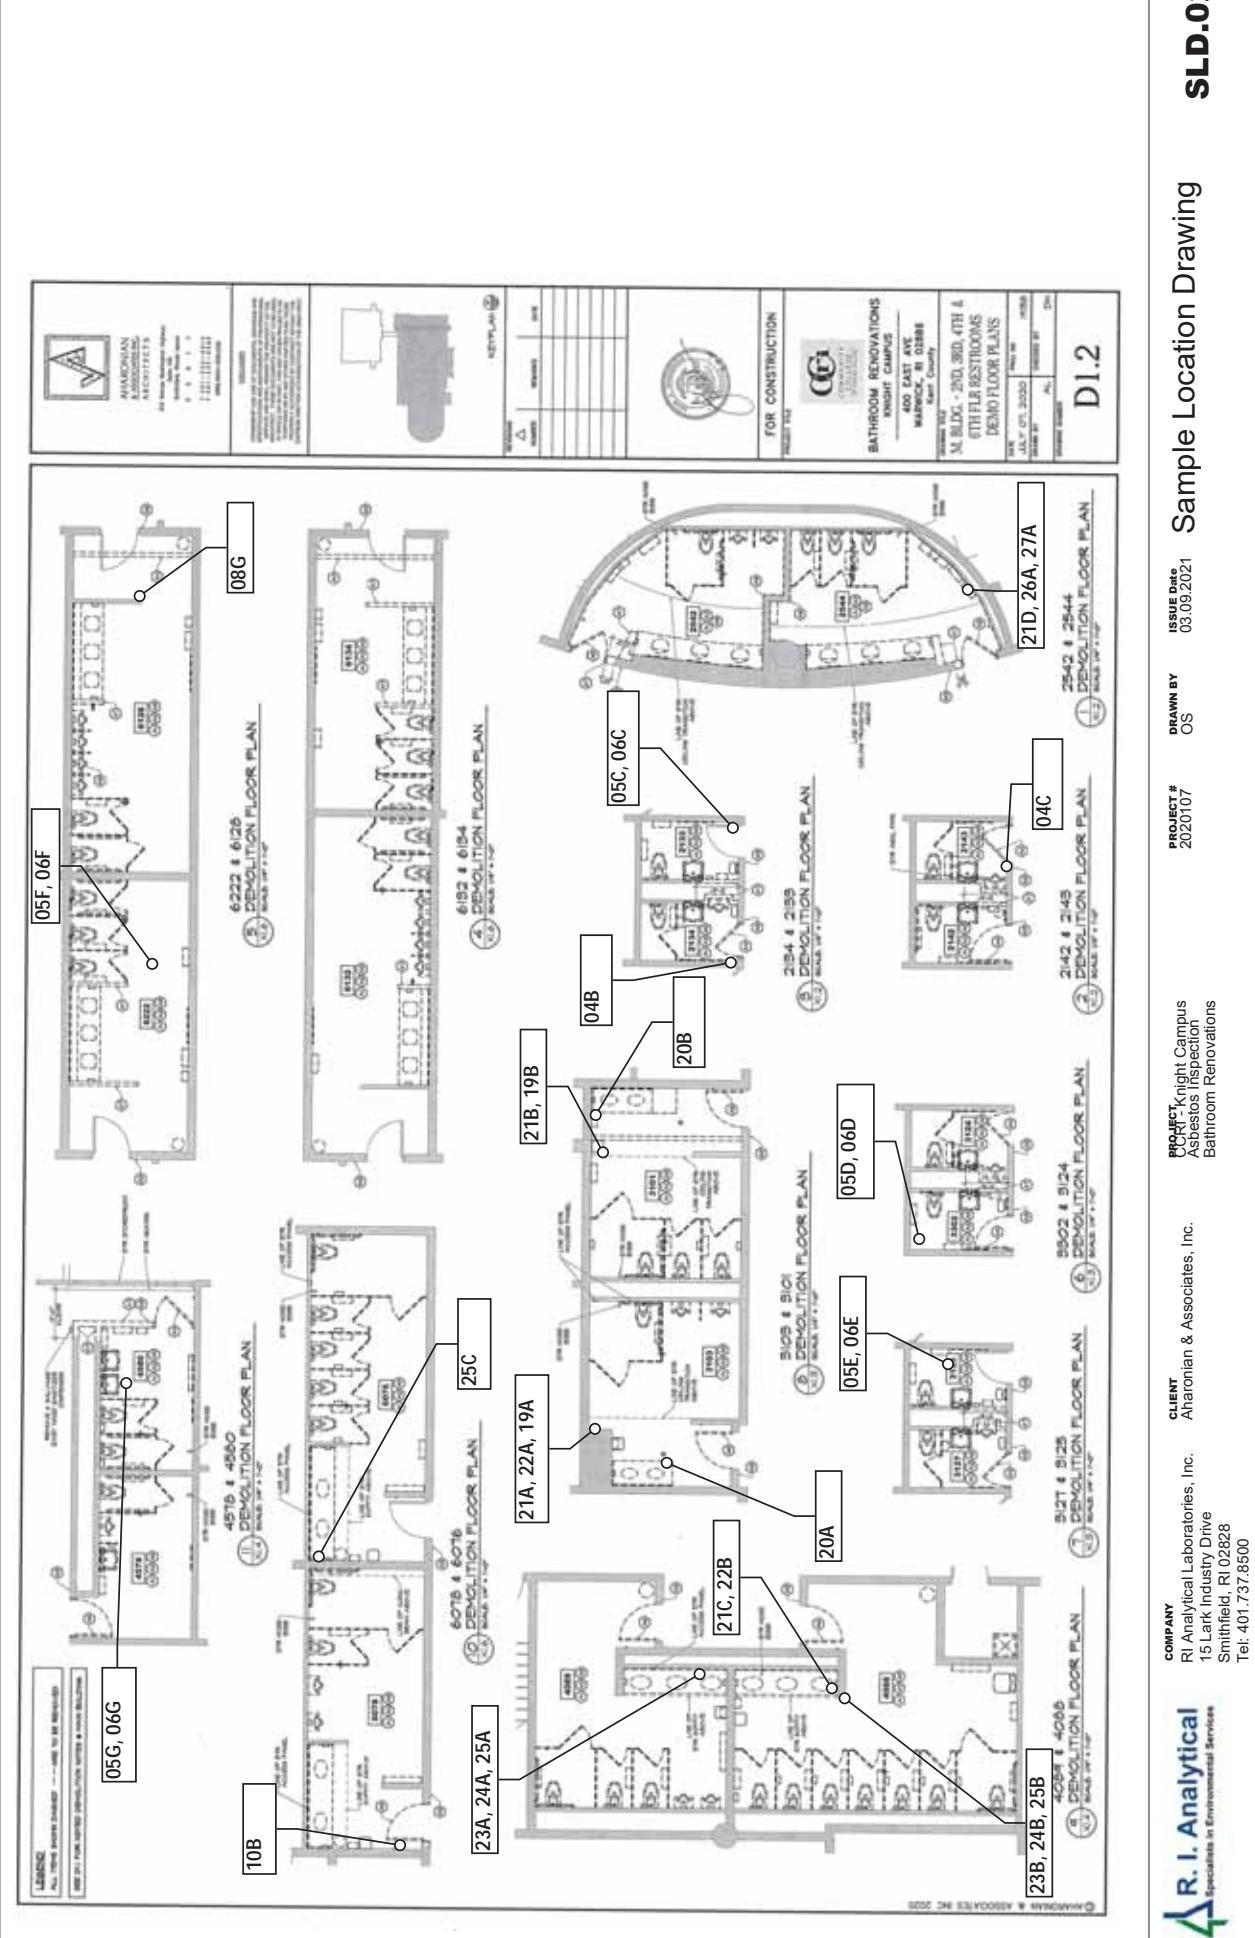
SLD.02

### Sample Location Drawings

Note: Sample numbers in red on the drawings tested as ACM (i.e. >1% asbestos) by Laboratory Analysis

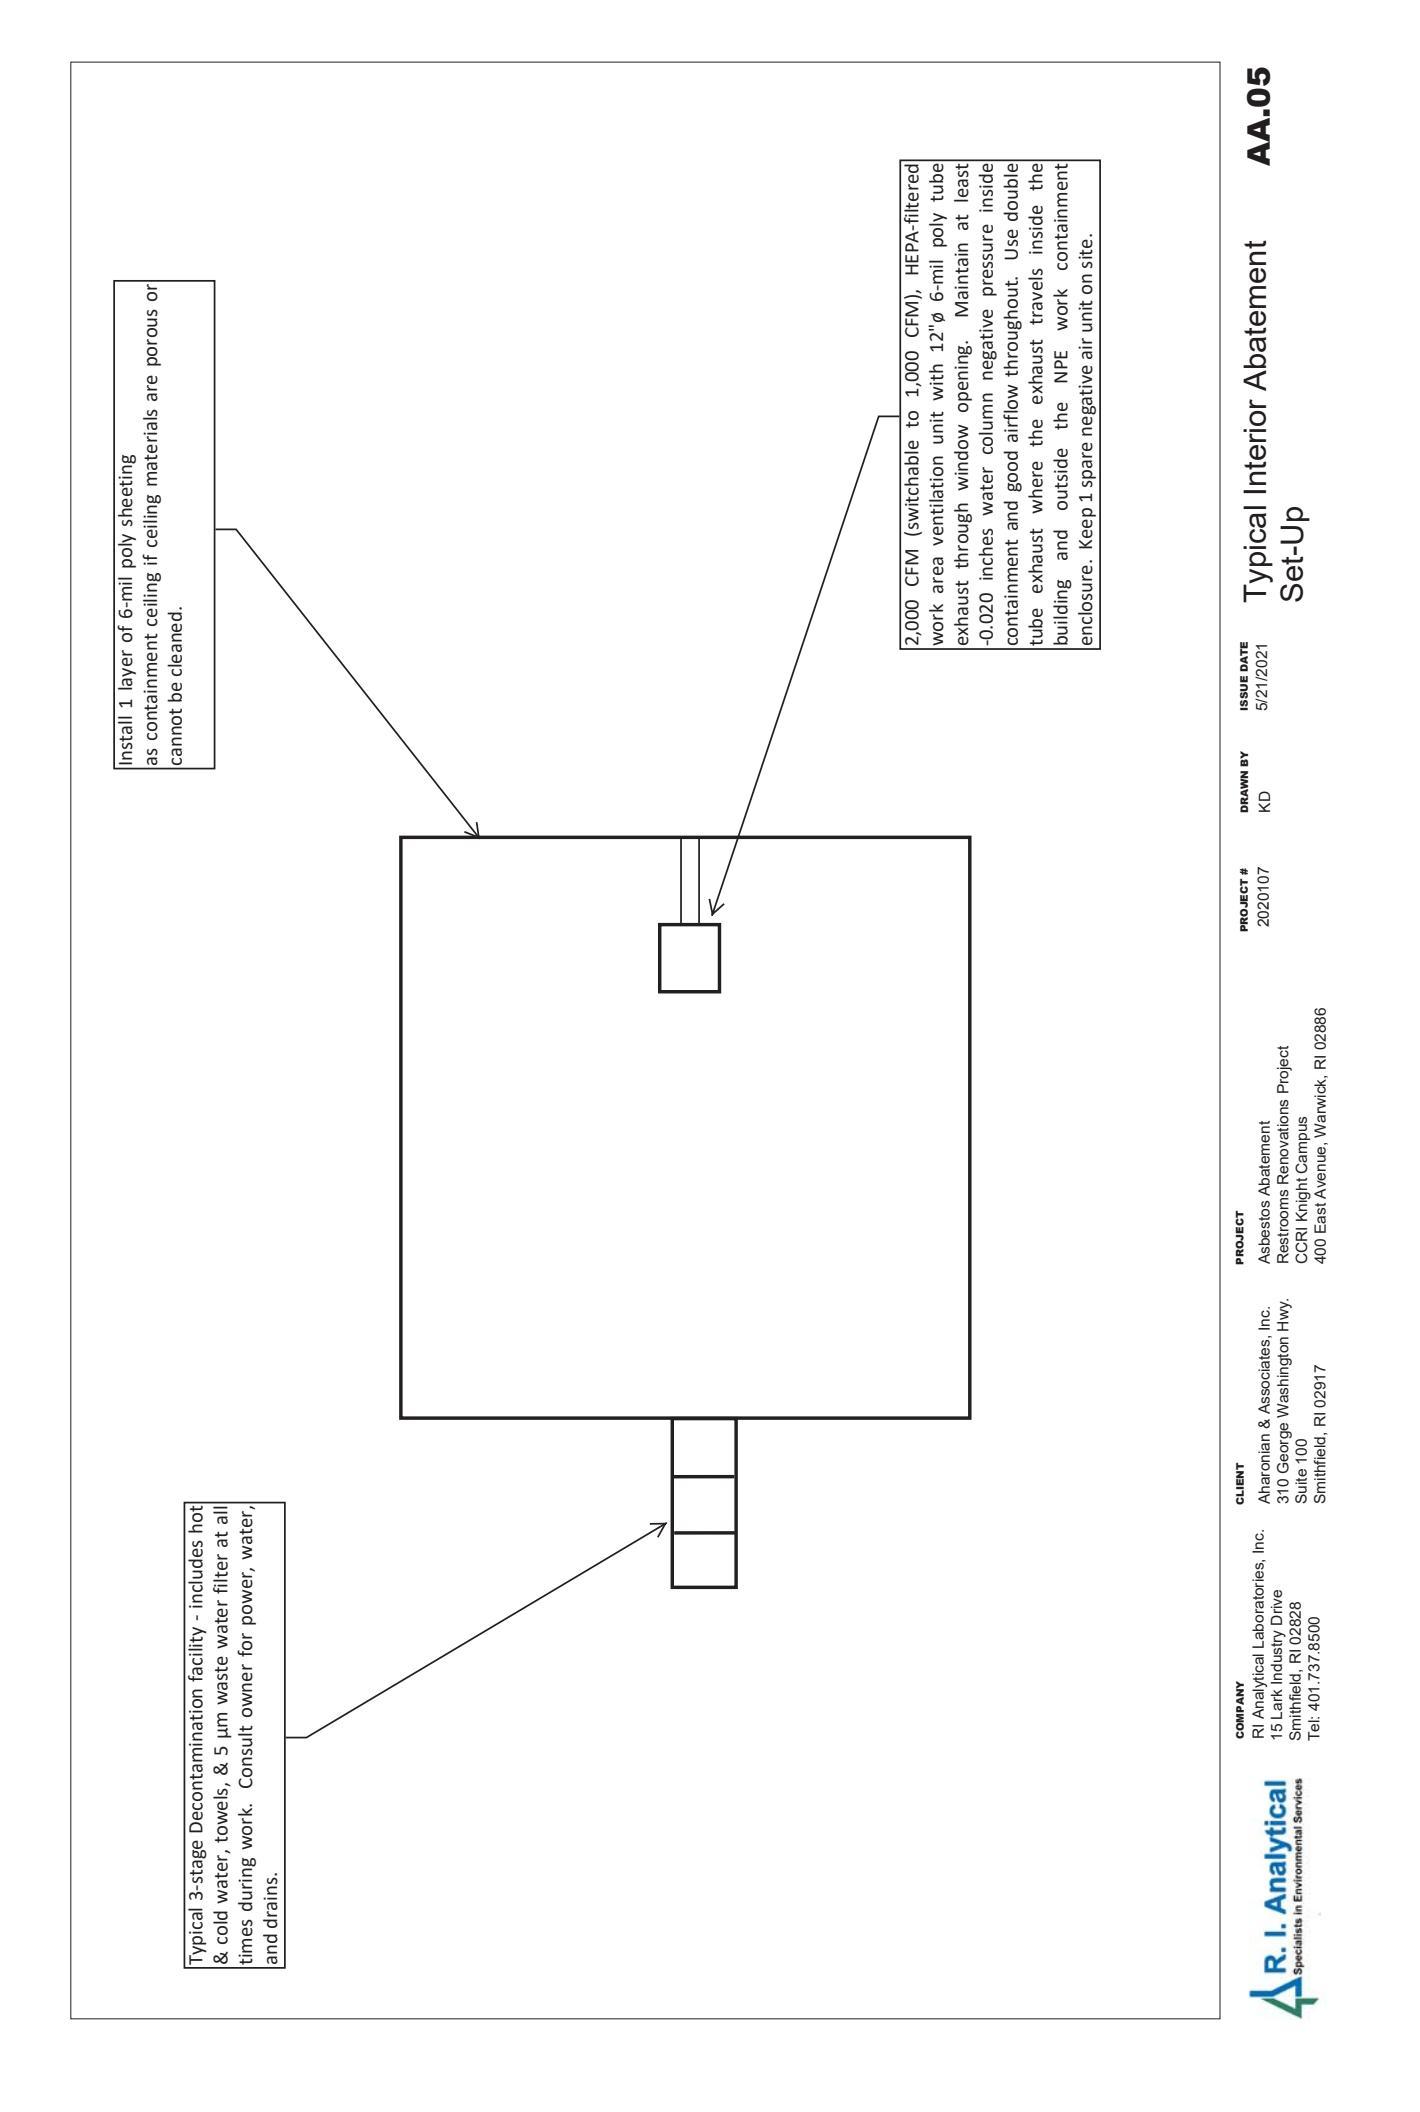
Drawings

- 21. Work area setups, decon locations, and HEPA unit quantities and locations are schematic only and site conditions, availability of water, power, and drains, as well as scheduling and other requirements may require modifications to be made Modifications shall be reviewed in advance with the IH.
